RICHELIEU RIVER BASIN  
COLCHESTER, VERMONT

**COLCHESTER POND DAM  
VT 00056**

**PHASE I INSPECTION REPORT  
NATIONAL DAM INSPECTION PROGRAM**

OCT., 1980

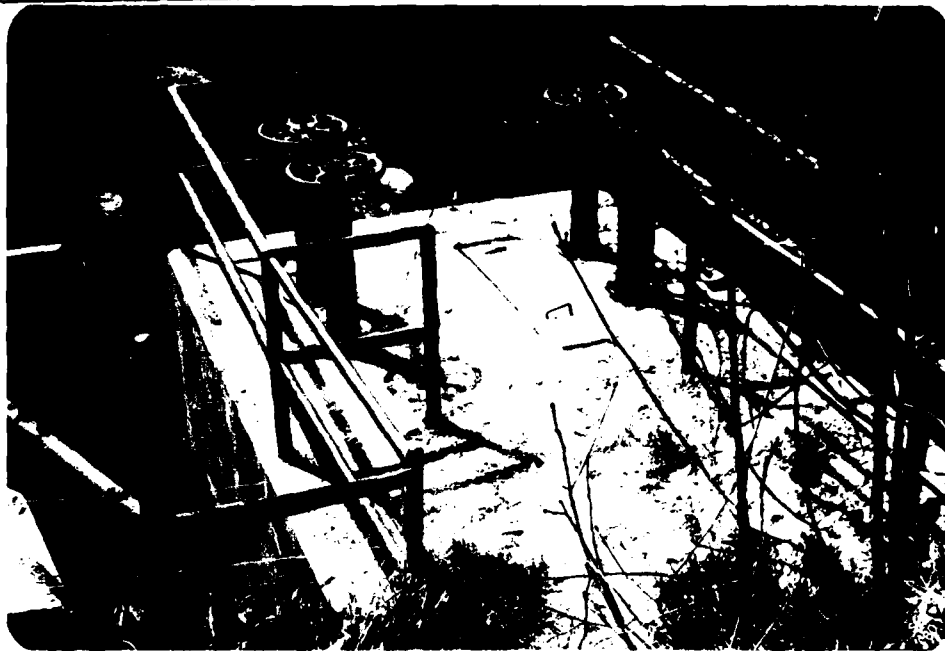
b. Dam - The dam is a reinforced concrete gravity structure with an operating platform at the right abutment 5 feet above the crest. The operating platform is shown in Photo 1. All visible concrete components of the dam appear in good condition.

(1) Operating Platform

The handrail around the operating platform, if allowed to deteriorate, could create a safety hazard to operating personnel.

- a. A program of biennial technical inspection, with repairs as necessary, should be instituted by the owner.
- b. A formal downstream warning system to be implemented in the event of an emergency at the dam should be developed by the owner within one year of the receipt of this report by the owner.
- c. A formal program of operation and maintenance procedures should be instituted and fully documented to provide accurate records for future reference.
- d. The owner should arrange for the removal of trees from the downstream channel within 50 feet of the dam toe.
- e. The handrail around the operating platform should be painted and maintained.

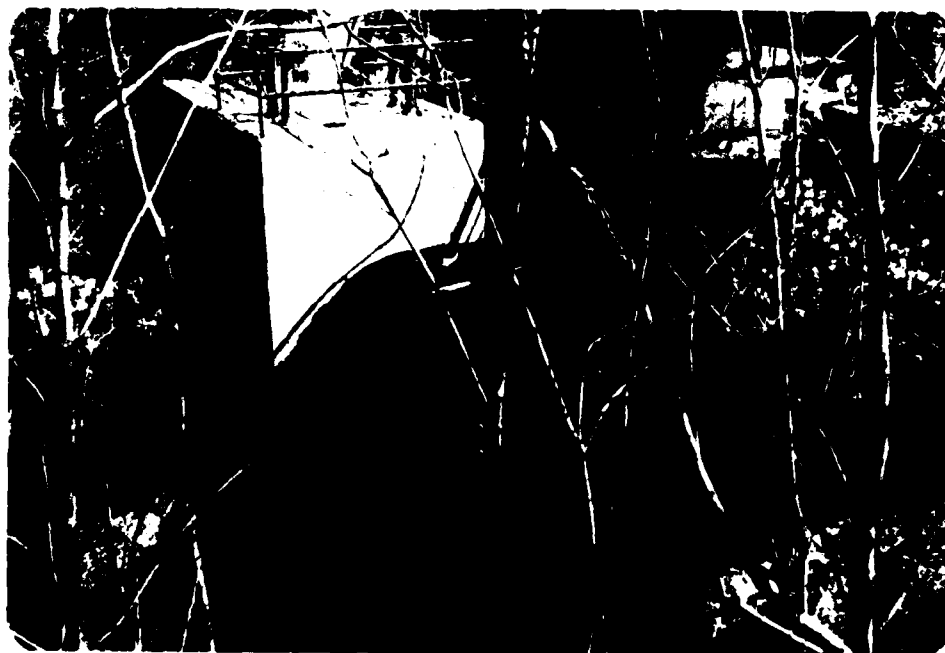
(4) Spillway Crest and Gate Structure, With  
Roadway Bridge Abutments at Right

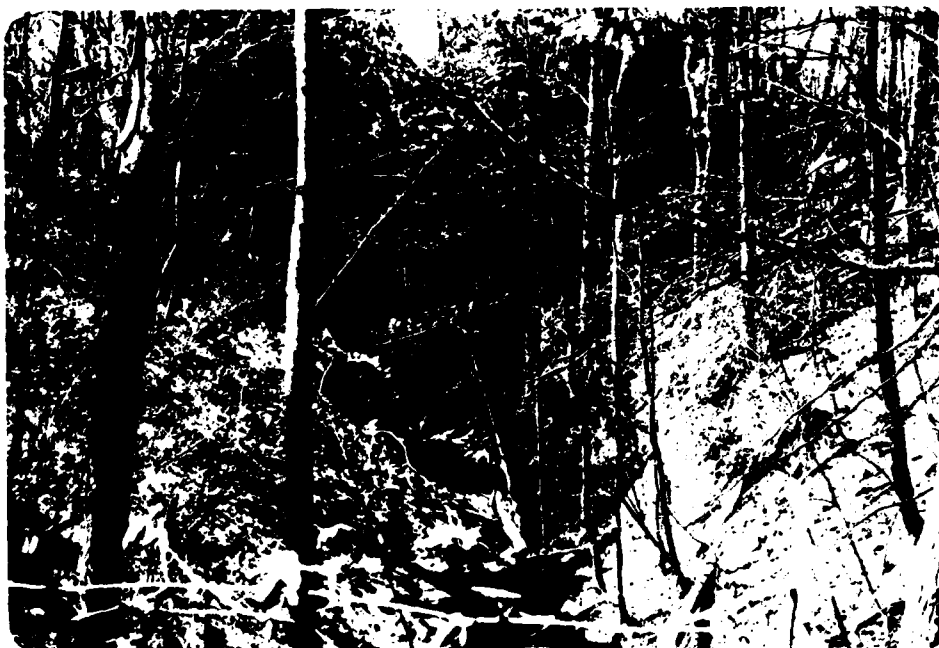
The heavily wooded condition of the downstream channel reduces the hydraulic efficiency of the channel and could result in downstream blockages and consequent damage during flood flows.

(10) Downstream Channel Immediately Below Dam
